FYVIE CASTLE, ABERDEENSHIRE

CAMERON ARCHAEOLOGY
January 2012

REPORT ON THE EXCAVATIONS AT FYVIE CASTLE, FYC/10/1 (CA014-2010) FYC/11/1 (CA040-2011)

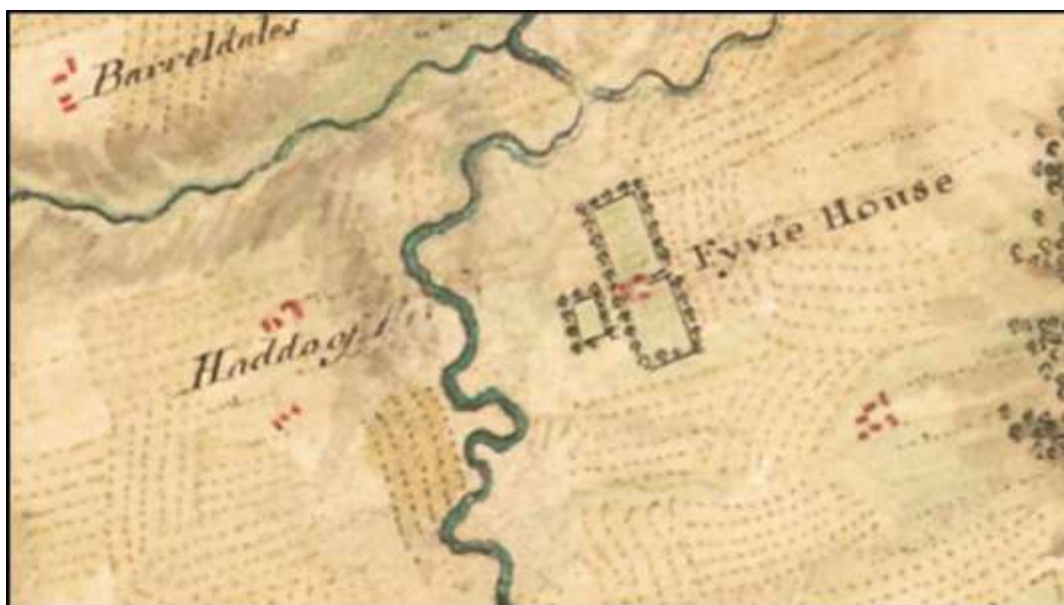
Figure 1: Extract from Roy's mid 18th-century map showing 'Fyvie House' (*copyright National Library of Scotland*)

3.1 Roy's map of 1750s shows 'Fyvie House' centred on two large enclosures and a small enclosure to the west sitting in ploughed land at the south-east of a bend of the river Ythan (Fig 1).

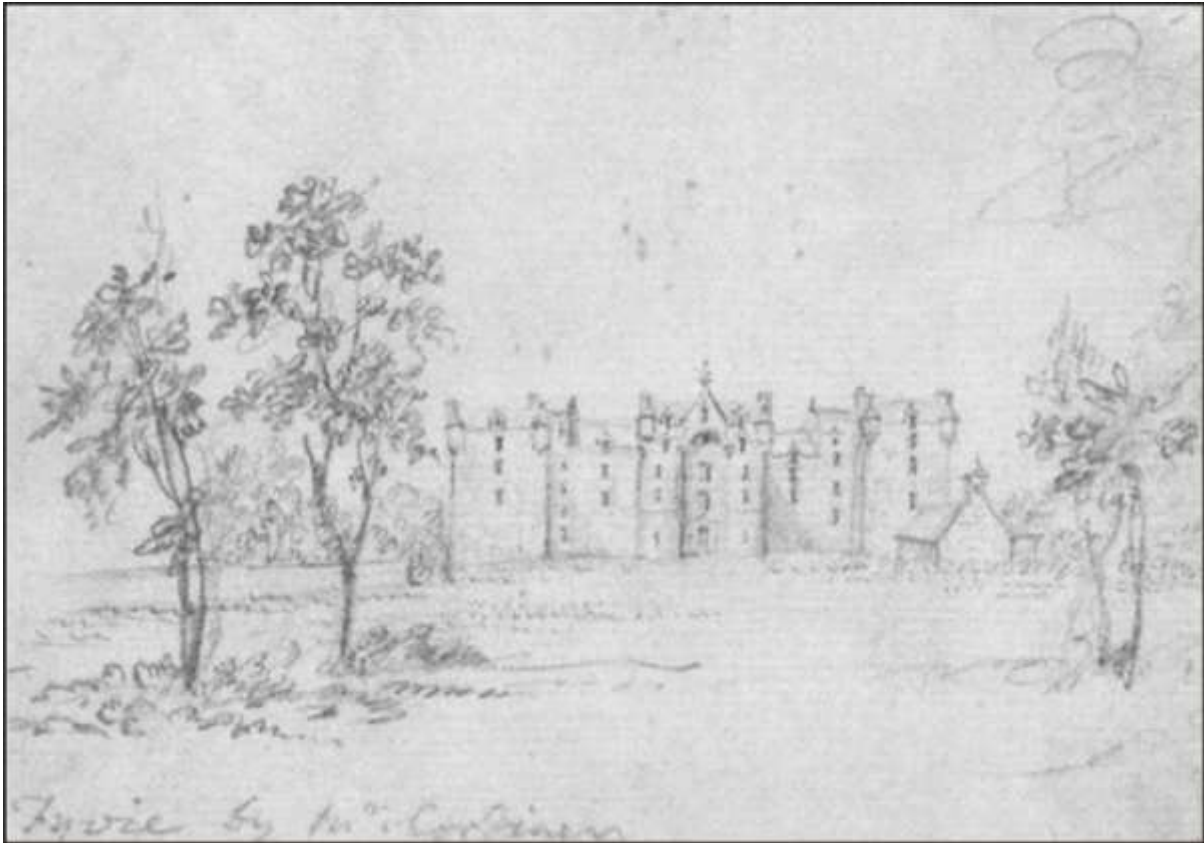
Figure 2: Drawing of south façade of Fyvie Castle, probably mid-late 18th century and by Charles Cordiner (copyright National Library of Scotland)

3.2 A mid 18th-century sketch (Fig 2) by 'Mr Cordiner' is probably by Charles Cordiner (1746-94) Episcopalian minister of Banff, who produced two books of drawings of buildings and landscapes of the north of Scotland in the late 18th-century. The sketch shows the south façade of Fyvie Castle from the garden. It shows a garden wall on the left (SW of the castle), a small building with the appearance of a chapel at the SE corner of the castle and a garden wall to the east (right) of the chapel building.

A structure constructed 3.5 metres south of the Preston Tower is probably the remains of the building seen on the Charles Cordiner sketch (Fig 2). The sketch shows a plain rectangular building with steep pitched roof, bird-cage bell-cote and what could be an extension or a garden wall to the east (right) of the image. Since the 2011 excavation it is most likely that this is the building excavated and that the wall to the east of the building on the sketch is the remains of the inner garden wall which has been partially demolished prior to the drawing. On the left (west) of the sketch the formal garden wall can be seen stretching from the SW corner of the building out to the south; evidence of that wall was found in Trenches 3, 5 and 1 during the 2010 season. The west side of the inner or private garden wall had been demolished by the time of the sketch. The fragment of garden wall was probably left standing next to the building because they were built in one phase and the removal of the garden wall would have caused the collapse of the building.

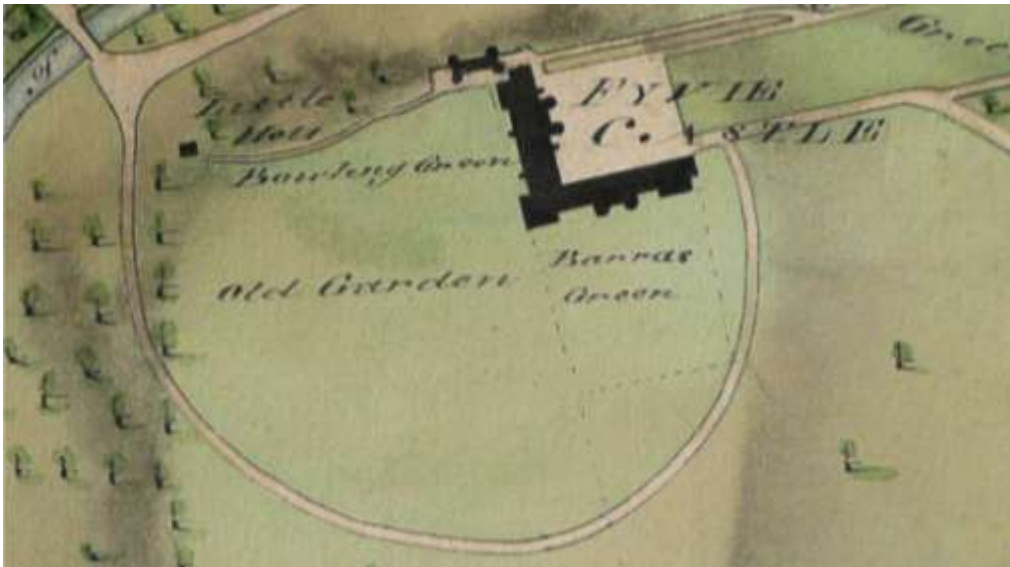
Figure 3: 1822 estate plan (copyright Fyvie Estate)

3.3 An 1822 estate plan by John Innes is housed with the current laird (Fig 3). The plan shows a bowling green west of the castle, Old Garden to the south-west and 'Barras Green' immediately south of the castle. The driveway is aligned closer to the castle than the current driveway and provides access to the castle just north of the Preston Tower.

At the east of Trench 1 a NNW-SSE drystone wall Feature 108 was 0.4m wide and at least 3.10m of its length survived. It consisted of medium water-washed cobbles with no obvious bonding material; no dating material was recovered. It is probable that this is a garden boundary wall at the top of the break of slope and may be medieval or later in date; this area is shown as the top of a south-east facing slope on the 1822 estate plan (Fig 3).

To the south of 307 were well-cultivated garden soils, 0.15-0.25m deep, suggesting that this was the northern boundary of the 17th-century gardens. The contexts to the north of 307 were compact gravels suggesting that this was outwith the cultivated area; this area is marked as 'Bowling Green' on an 1822 estate plan (Fig 3).

The inner garden is the term used in this report for the area immediately south of the current castle south facade. On the 1822 estate plan (Fig 3) this area is called the 'Barras Green'

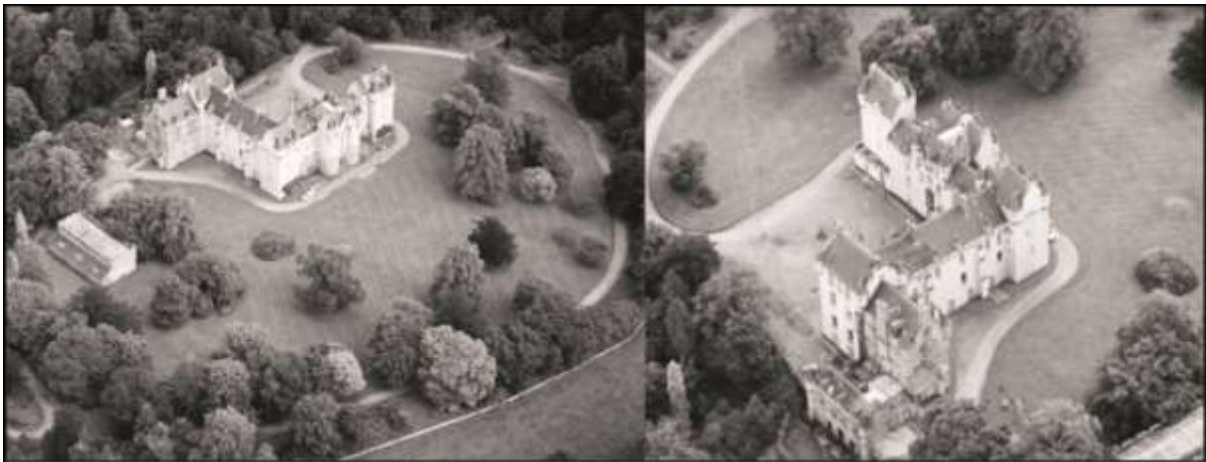
Figure 4: 1985 aerial photographs (copyright Ian B Ralston Aberdeen Aerial Surveys)

3.4 A series of aerial photographs have been taken of the castle (Fig 4). Certain features can be seen including a service trench running on a NW-SE alignment to the east of the castle and a circular mound but nothing of the old gardens can be seen.

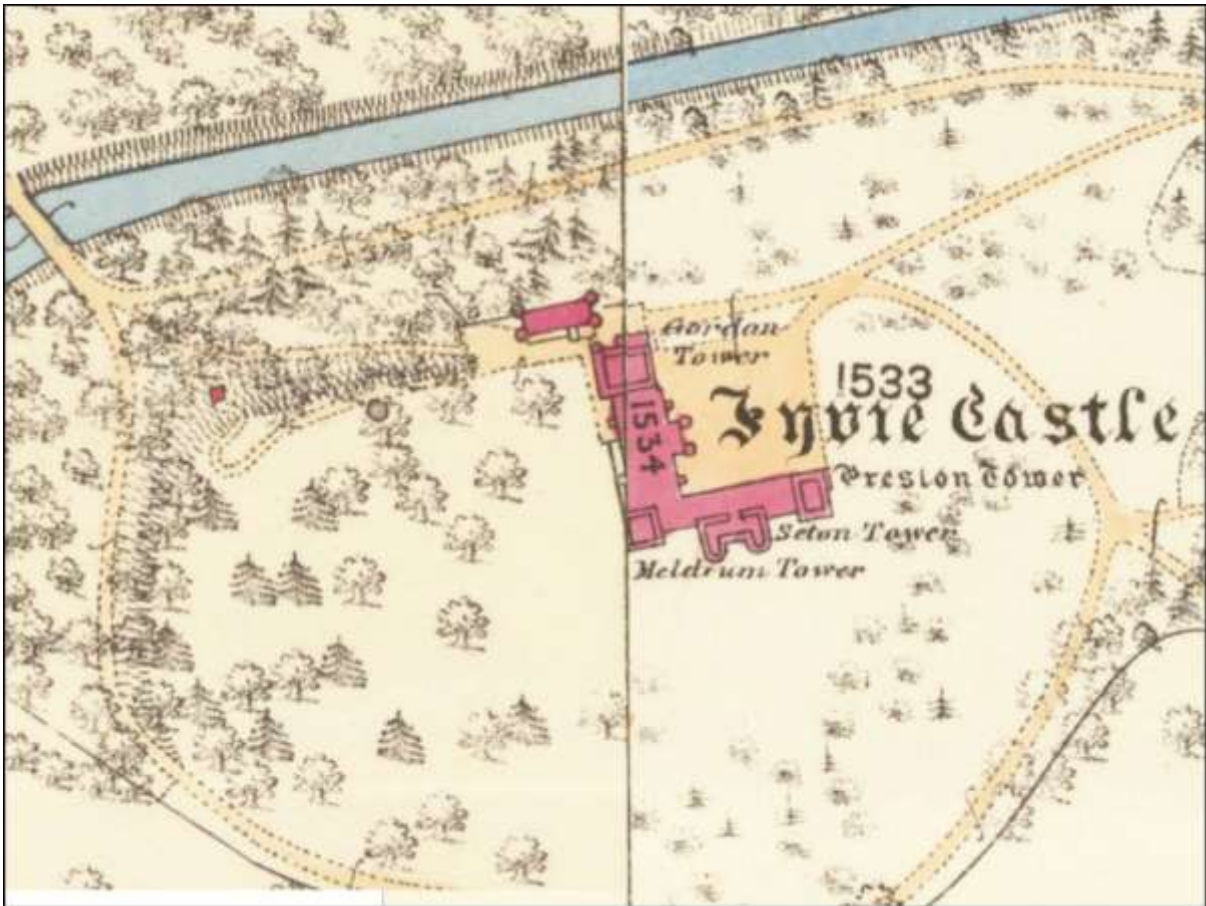
Figure 5 First Edition Ordnance Survey map (copyright National Library of Scotland)

3.5 First, Second and Third Ordnance Survey maps (1869, 1900, 1905) show Fyvie Castle with very little difference to the current castle. The First Edition (Fig 5) shows the west side of the south lawn is heavily treed and the eastern side more sparsely vegetation covered.

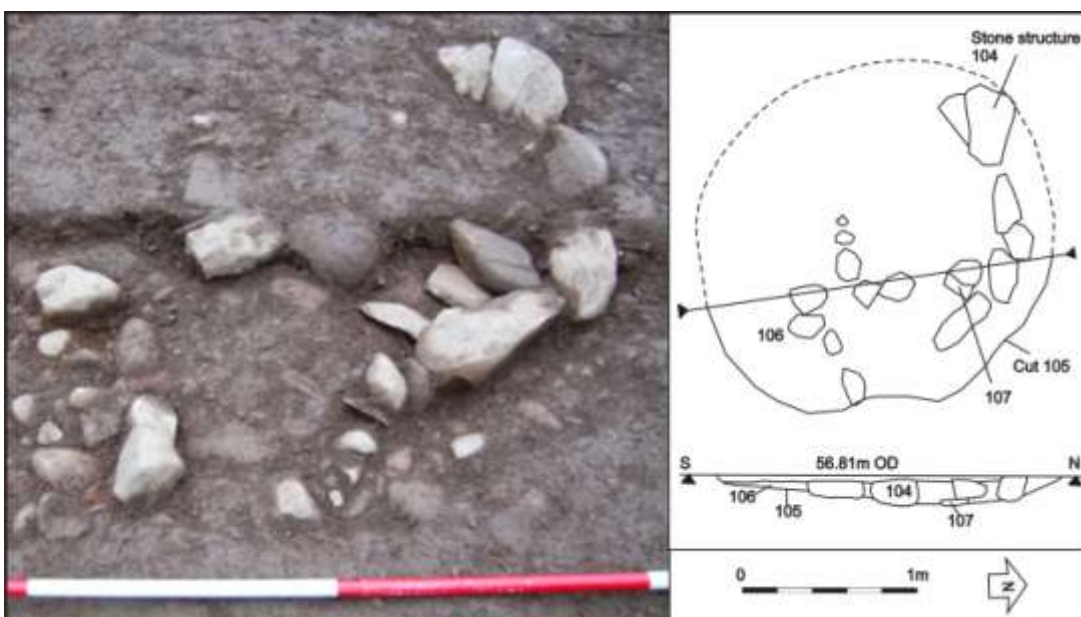
Figure 9 (left) Kiln 105 facing west, plan and section (right)

A circular area of stones, 1.9m diameter and with burning in the centre was the remains of a clamp kiln. Boulders had been set upright in a shallow scoop cut into the natural gravels; flat stones placed at the base showed evidence of burning. Several fragments of daub were recovered from the topsoil above this feature but no finds were recovered *in situ*.

This type of small clamp kiln was used during the medieval and post-medieval period for the production of pottery and tiles. It is likely that this was used for the production of ceramic floor or roof tiles for one of the building campaigns at the castle. Tiles were heavy and were often produced near to where they were required. The remains of clamp kilns were often found at religious institutions such as friaries (eg Aberdeen Carmelites, Cameron *et al*, forthcoming). No ceramic roof or floor tiles were recovered from the excavation but as finds were very sparse this is not considered significant.

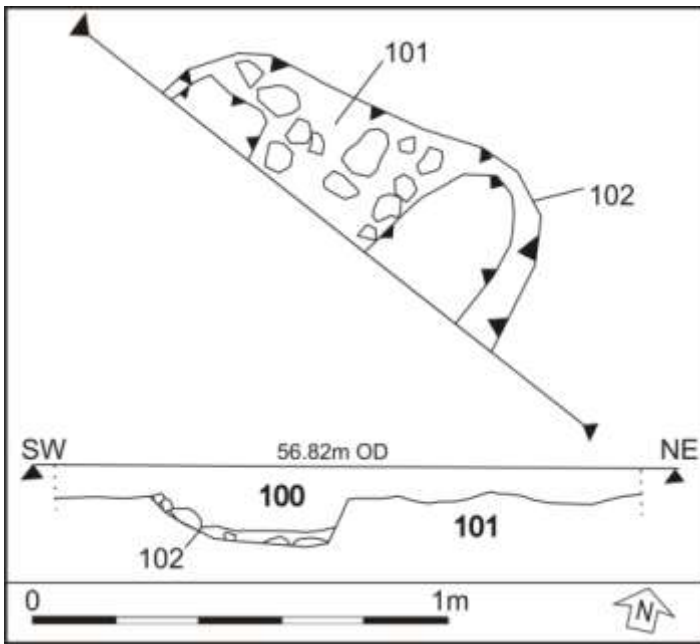
Figure 11 Cut 102 plan and section

The third feature investigated in Trench 1 was in the NW corner. Feature 102 consisted of two shallow scoops cut into the natural gravels and filled with topsoil. No evidence of use or dating was present and it may have been a garden feature. Plans indicate that this end of the trench was probably scarped for the construction of the driveway seen in the 1822 plan (Fig 3) which may explain the poor survival of features in this area of the garden.

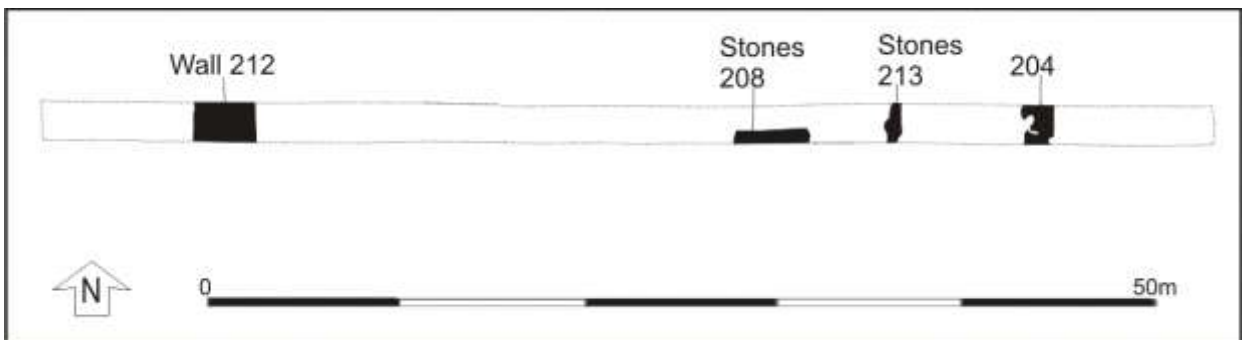
Figure 12 Trench 2 all features

Trench 2 was located in the south-west of the castle lawn and was 2m wide and 66m long. It was positioned in the area thought to have been occupied by the 17th-century garden and many resistance anomalies suggested this (Ovenden 2010). Topsoil in this trench was 0.1-0.2m deep.

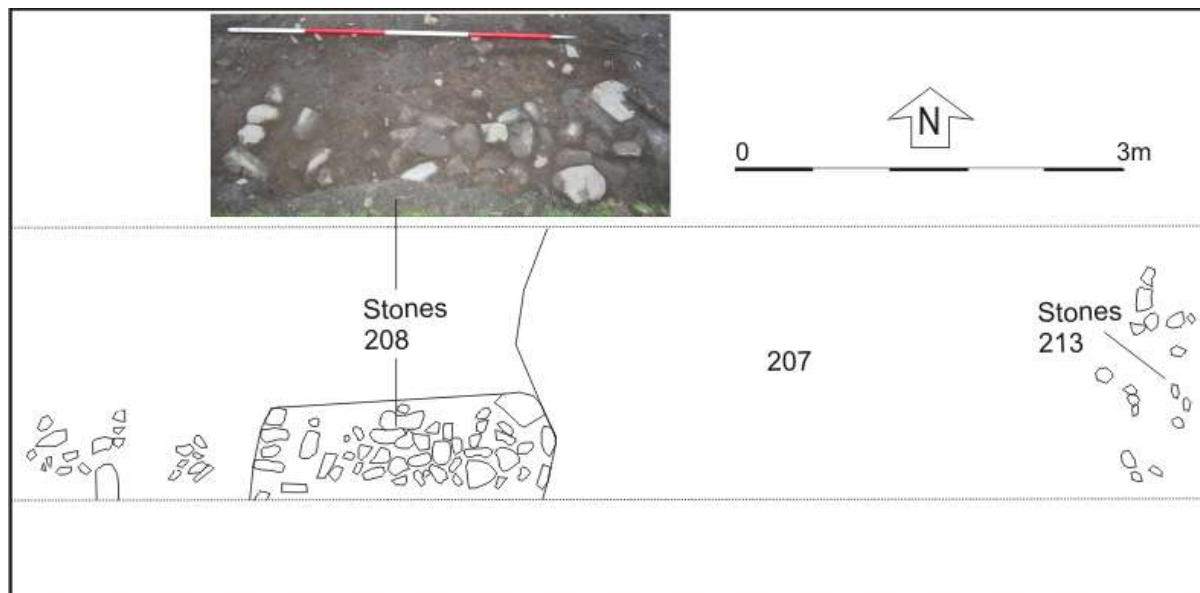
Figure 13 Plan of stones 208 and 213 and photo of 208 (above)

The earliest features in this trench were located under garden soil 214. They consisted of a sub-rectangular area of stones set in clayey loam, 208 which was

2.2m long and exposed to a width of 0.75m. Further stones to the west may have originally been part of this feature. Finds associated with this feature included medieval pottery but no later finds. Several of the sherds of medieval pottery were burnt and this may represent rubbish from the castle's kitchens. The stones may have been a cobbled path associated with the medieval castle or gardens.

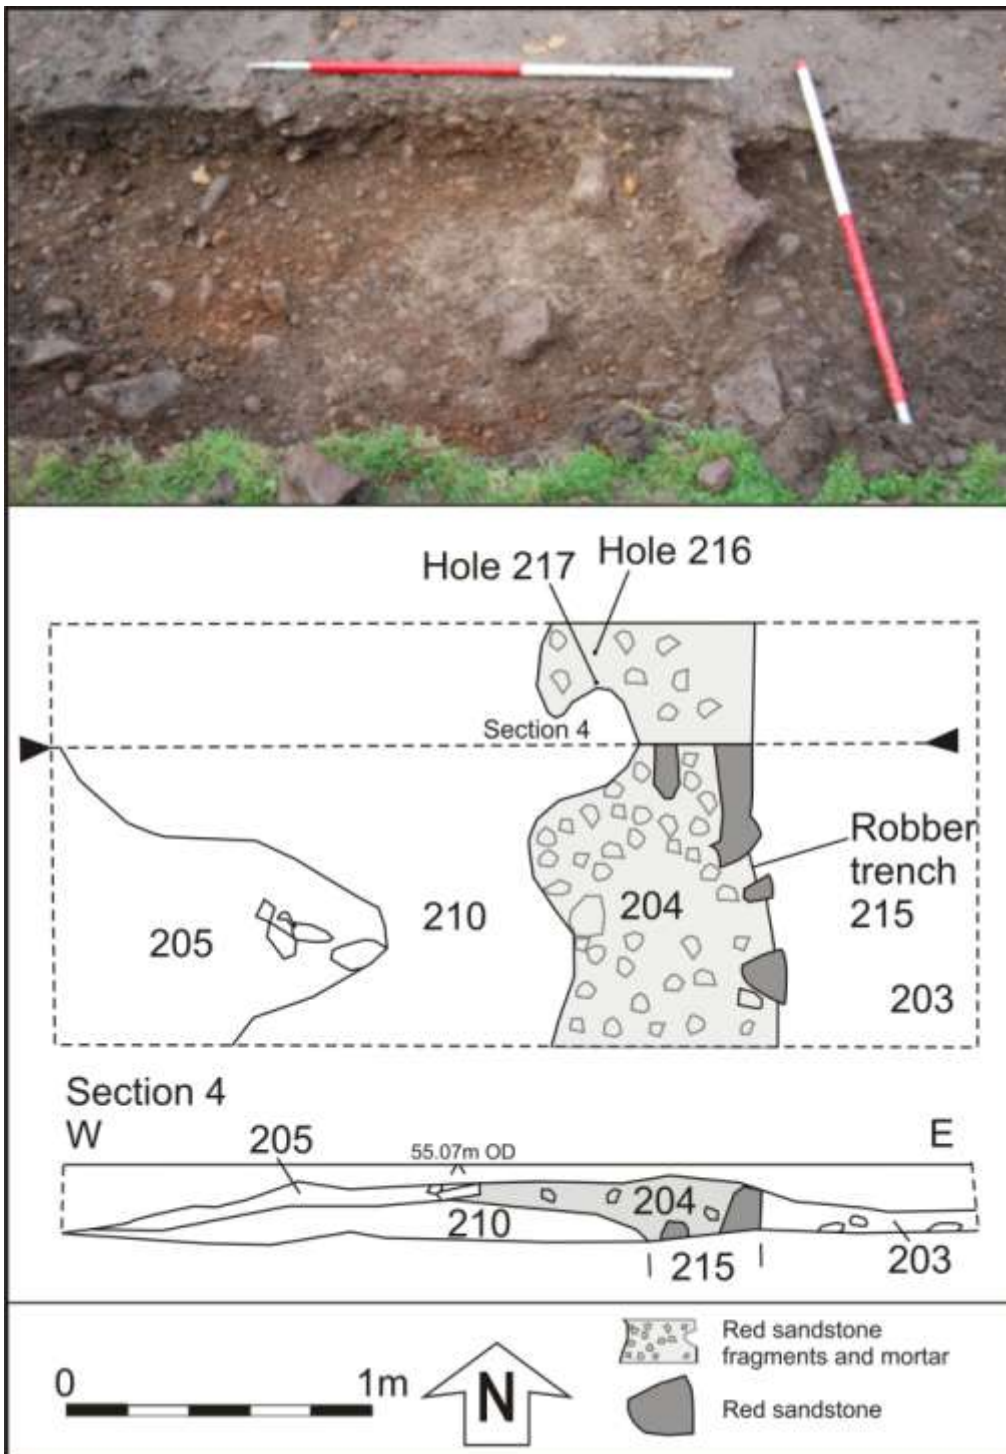
Figure 14 Trench 2 robber trench for east garden wall 204/215

Towards the eastern end of the trench a spread of mortar and red sandstone fragments, some probably *in situ* (204) was 0.75m wide and the width of the trench. Under this a N-S robber trench (215) contained mortar and sandstone fragments suggesting the feature was originally a mortared red sandstone wall. This foundation was the remains of the robbed east wall of the 17th-century formal garden (Fig 3) and is shown in the 18th-century sketch of Fyvie Castle (Fig 2) adjacent to the castle.

130 red sandstone blocks and fragments were found in various contexts. Sandstone fragments were found around all the garden walls (212, 204/215, 307) suggesting that they had been constructed from sandstone blocks which had been completely removed when the gardens were dismantled.

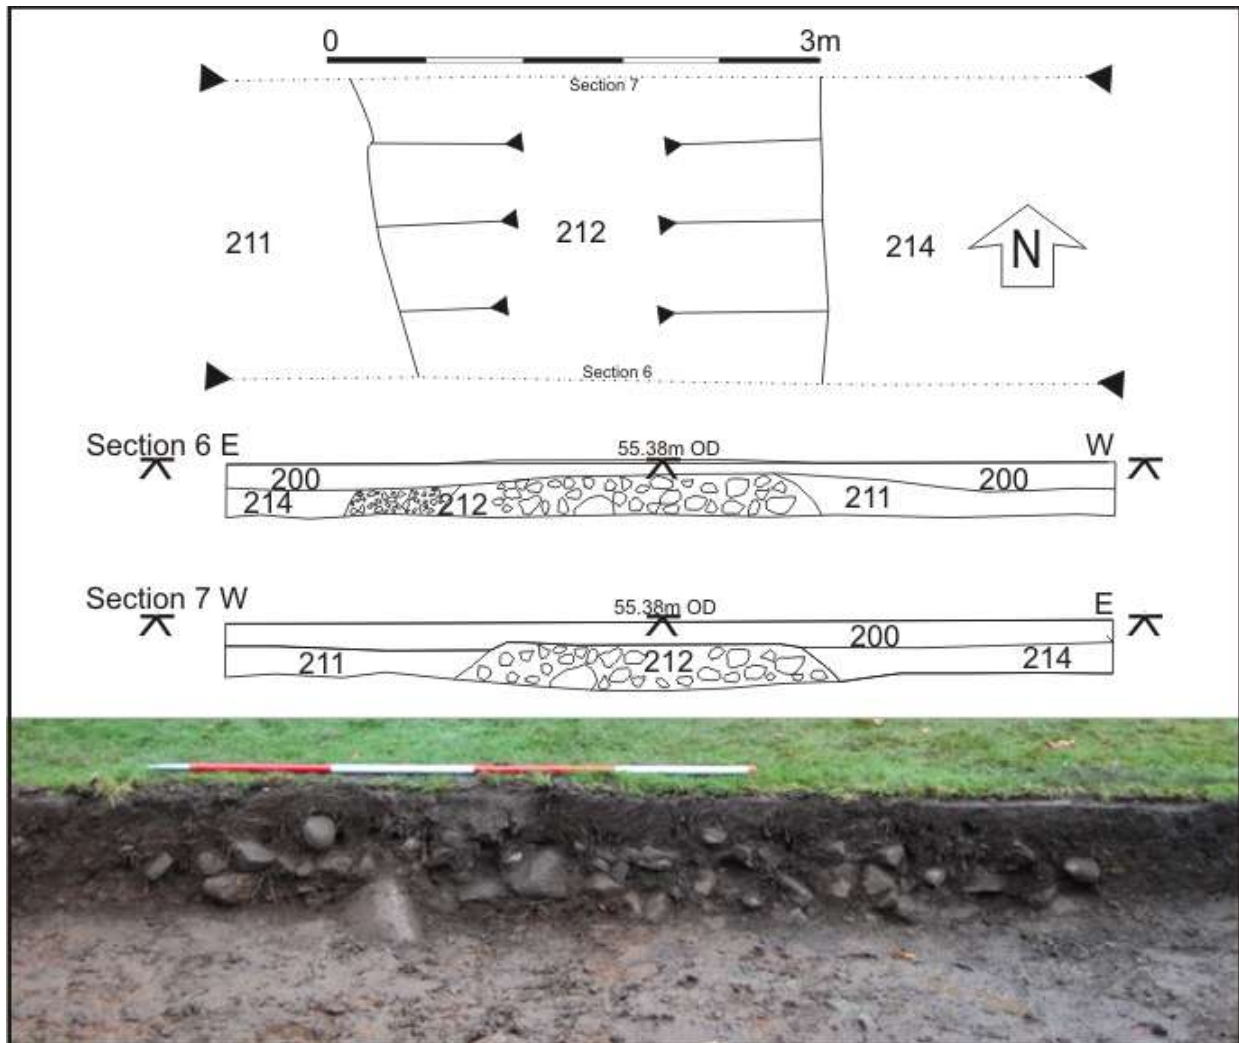
Figure 15 Garden drystone feature 212; facing north

Feature 212 was c 3.3m wide, up to 0.35m high and was a minimum of 0.1m below the current level of the lawn creating a slight linear earthwork. It consisted of a N-S bank of water-washed cobbles with no obvious bonding material. It appeared to be a spread of stones from the demolition of a drystone wall or other drystone garden feature. To the east of 215 and the west of 212 the soils were compacted gravel subsoil whereas to the soils in between them were very rich

garden soil loams, 0.15-0.25m deep. It was 45m from main wall 204 and was probably the remains of a drystone partition within the garden.

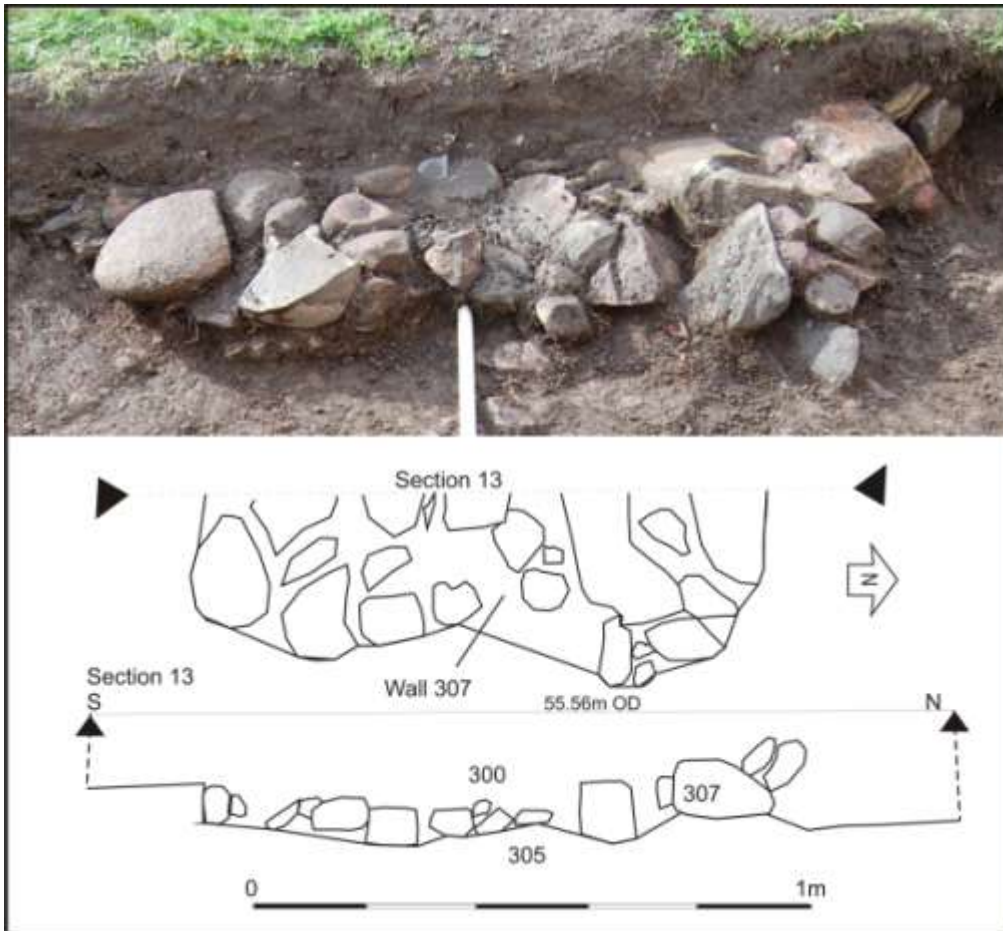
Figure 17 Wall 307 photograph, plan and section

Granite wall foundation, 307, was 1.6-2m wide and appeared to be unbonded. It appeared to be the termination of a wall, possibly for a gate. Around the features was a layer of red sandstone fragments (305), probably from construction of wall 307 and this layer may indicate that the wall did originally continue to the east suggesting that the terminal 307 was one side of a gate. The Cordiner drawing seems to show that there was a gap between the garden wall and the Castle at approximately this location (Fig 2).

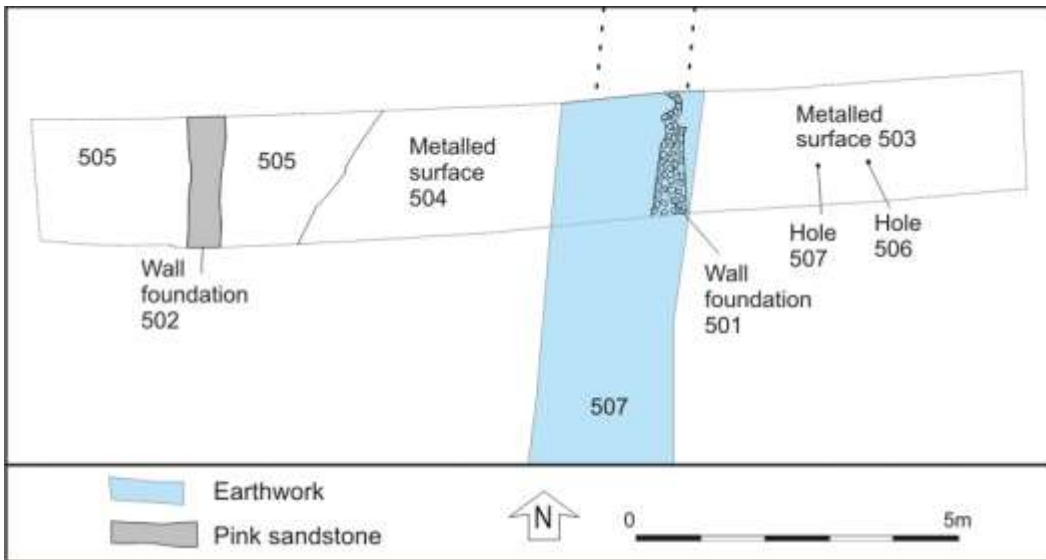
Figure 18 Trench 5 plan of all features including earthwork 507

Small stone wall foundation 501 (Fig 18, 19) was a maximum of 0.6m wide and appeared to be unbonded. It was the cause of the upstanding earthwork running south from the SW corner of the current castle and had a minimum of 0.1m of turf covering. Following the 2011 excavation and recording of the earthwork associated with feature 501, it is likely that 501 forms the east edge of a wall, possibly the inner garden wall. The wall was surrounded on both sides by metallised surface, 504, at 55.40m OD, a similar height to metallised surfaces found in the base of Trench 4 post-holes, and at the base of features in Trench 6 and Trench 8. No further excavation took place in this trench and so it was not possible to determine the relationship between 501 and 504.

Pink sandstone 'stripe' (502; Fig 18, 19) north-south across Trench 5 was left unexcavated. Due to its nature and location on the resistance survey, it has been interpreted as the remains of the post-medieval garden wall seen in Trenches 2 and 3.

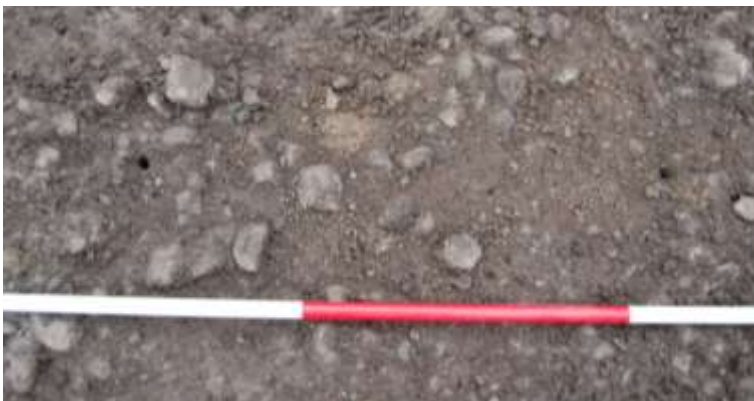
Figure 21 Marquee holes 507 and 506 in metallised surface 503; facing north

Two oval marquee holes, 506 and 507 (Fig 21) were 0.02 x 0.04m in size and are evidence of pegs being forced through the metallised surface 503.

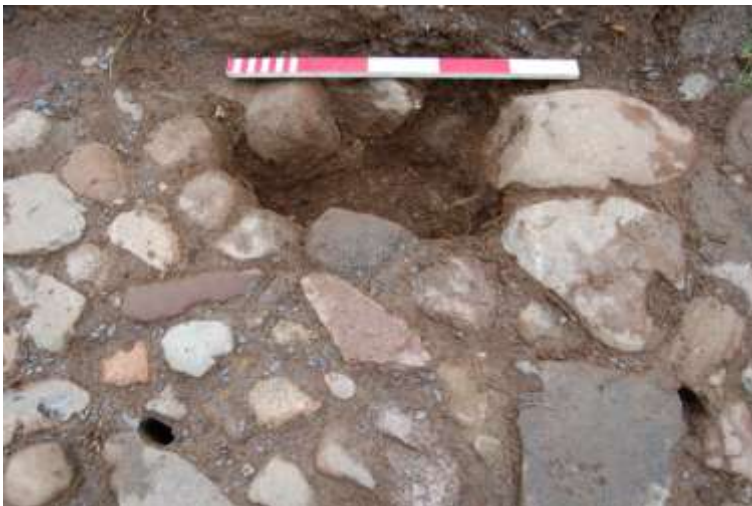
Figure 27 Marquee holes 414 (left) and 413 (right) in cobbles 402; facing west

Three probable marquee holes were recorded in this trench (Fig 27). Holes 413, 414 and 421 were all oval, 0.02 x 0.04m in size and had been forced between the stones of cobbles 402 and 404.

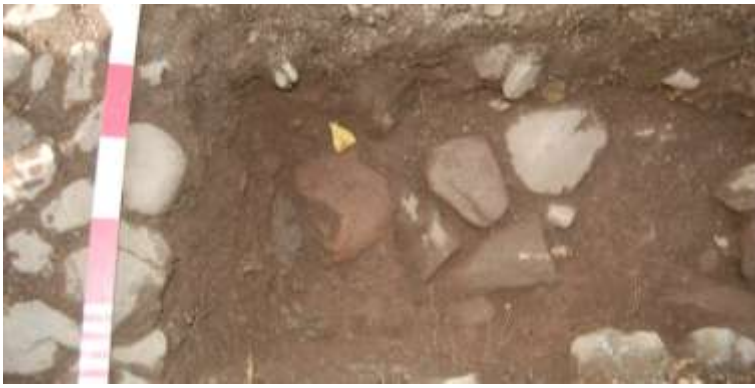
Figure 28 Possible stone surface 617 in base of trench 6; facing north

The earliest feature in this trench was an area of stones (617; Fig 28) seen in the base of the box section through wall 605. It may have been a rough surface or stone rubble. It may have been a rough surface or stone rubble and is approximately the same level and the cobbled surface found in the base of post-holes in Trench 4. Only 0.8 x 0.5m was revealed and no dating evidence was recovered. This looks similar in nature to the earliest stone features in Trench 2 and may also be related to the medieval gardens.

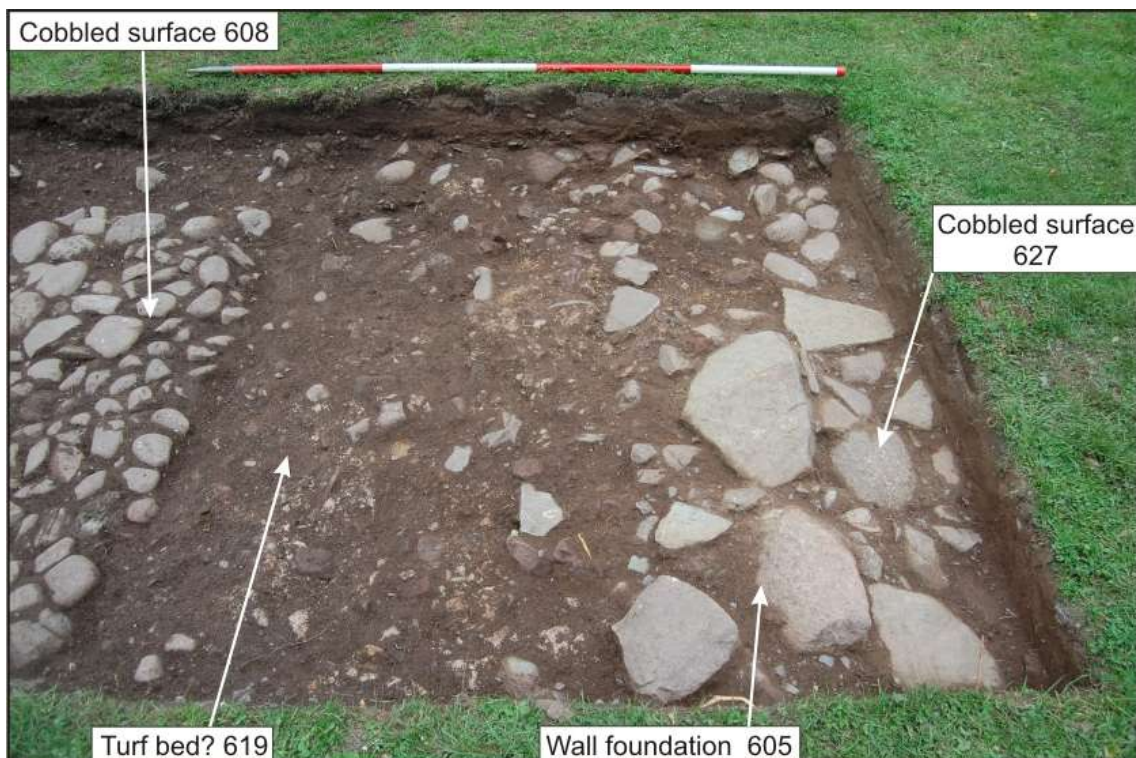
Figure 29 Trench 6, 608, 605 and 627 facing north

The west wall foundation of Building 402 (recorded in 2010 Trench 4) and the edge of cobbled surface 627 (402 in Trench 4) was identified at the east end of the trench. Wall foundation 605 consisted of large facing stones with some of the hearting (615) intact and had been 0.7-0.8m wide. The west facing stones had been removed from the wall foundation leaving the east facing stones and hearting intact. A cut for the robber trench was 0.2m wider than the wall foundation (628; Section 15; Fig 31). The larger stones of the wall foundation have been completely removed on the west side of the feature.

The robbing of stones from these features is not uniform which may suggest that only certain types and amounts of stone were required for the building programme taking place at the time of demolition of these structures. It may suggest that at some point enough building materials had been reclaimed and the remainder was left *in situ*.

Surrounding the inner, private gardens probably built by Alexander Seton was a red sandstone wall located in Trench 10 adjacent to the castle and Trench 7 where it survived as a foundation. In Trench 5 it survived as a small stone foundation or robber trench with some upstanding stonework (501) probably causing the upstanding earthwork. In 2011 this earthwork, which surrounds the area called 'Barras Green' on the 1822 plans, was recorded. It aligns well with the Trench 5 features (Fig 29). The area enclosed by these features is c 410m E-W and c 360m N-S (1345 x 1181 feet).

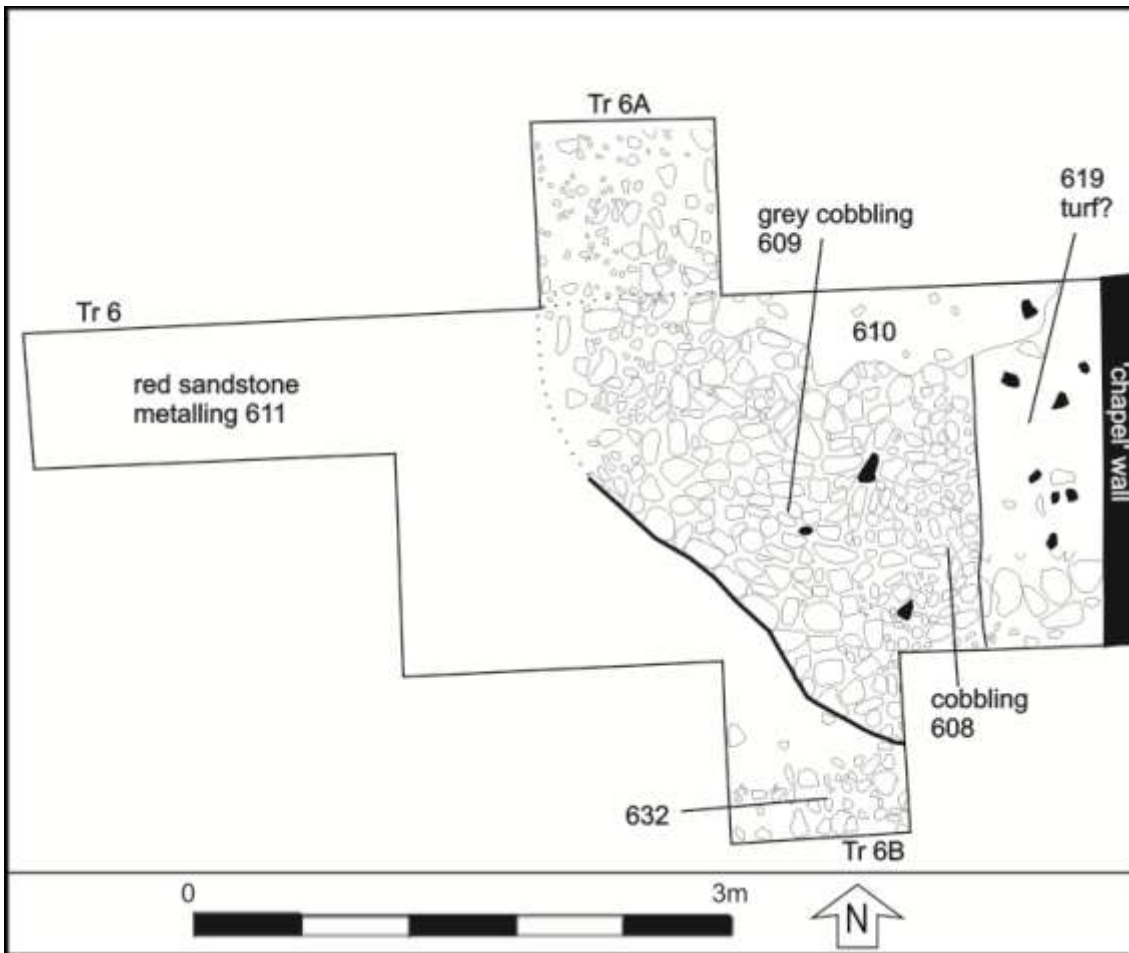
Figure 32 Garden features

West of the possible chapel building were features thought to be associated with a formal garden. Adjacent to the exterior of the west chapel wall was a linear area of soil (619) c 0.5m wide (Fig 32). This contained no stones, was not organic in nature and contained virtually no finds. It is likely that this was an area of turf rather than a planted bed. West of this were areas of grey granite fieldstone cobbles and, further west again, a metallated surface made from red sandstone chips (611). The granite cobbles immediately adjacent to the turf bed 619 comprised an area of small angular cobbles (608) c 0.5m wide.

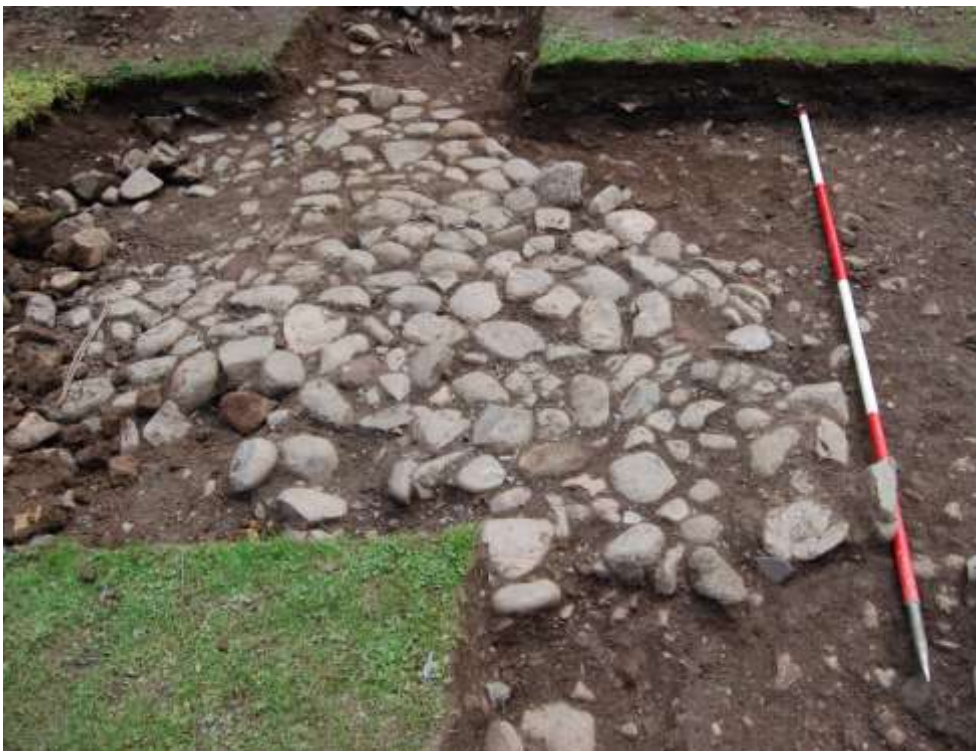
Figure 33 Cobbled surface 609; facing south

Adjacent to this was an area of larger rounded granite cobbles with a scalloped edge (609). The boundary between 608 and 609 was not very distinct and may not have been linear. Two distinct patterns were seen in the cobbles and these are illustrated in Fig 34: these may be due more to the workers laying the cobbles or may be an attempt at creating an effect of small cobbling adjacent to the turf bed.

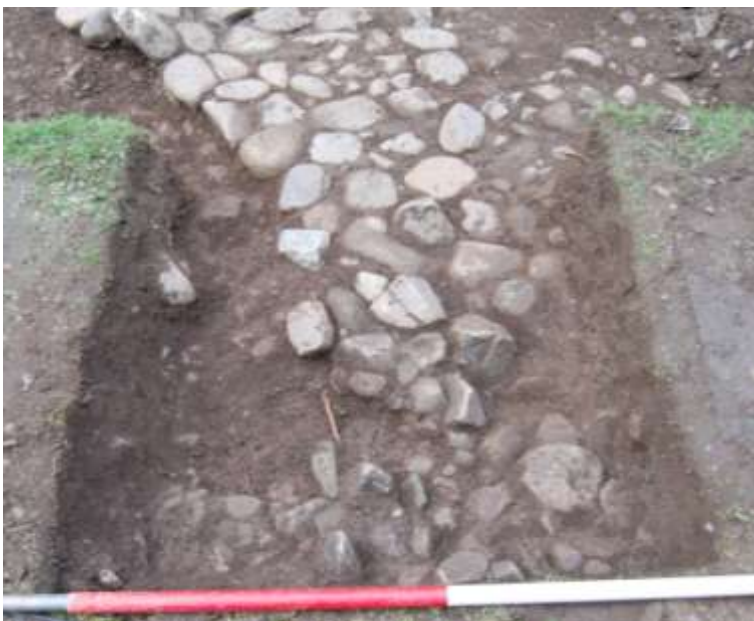
Figure 35 Trench 6B cobbled surface 609 (top) and linear stone feature 632 (foreground); facing north

Demolition material over these garden features was up to 15cm thick and consisted of small fragments of slate which appeared to have been trampled *in situ* whereas over the building the fragments of slate were much larger. This presumably occurred when estate workers with horses and carts were dismantling the building. A linear arrangement of small stones (632; Fig 32) in the extreme south of the trench extension 6B may be a result of demolition or may be associated with a linear garden feature.

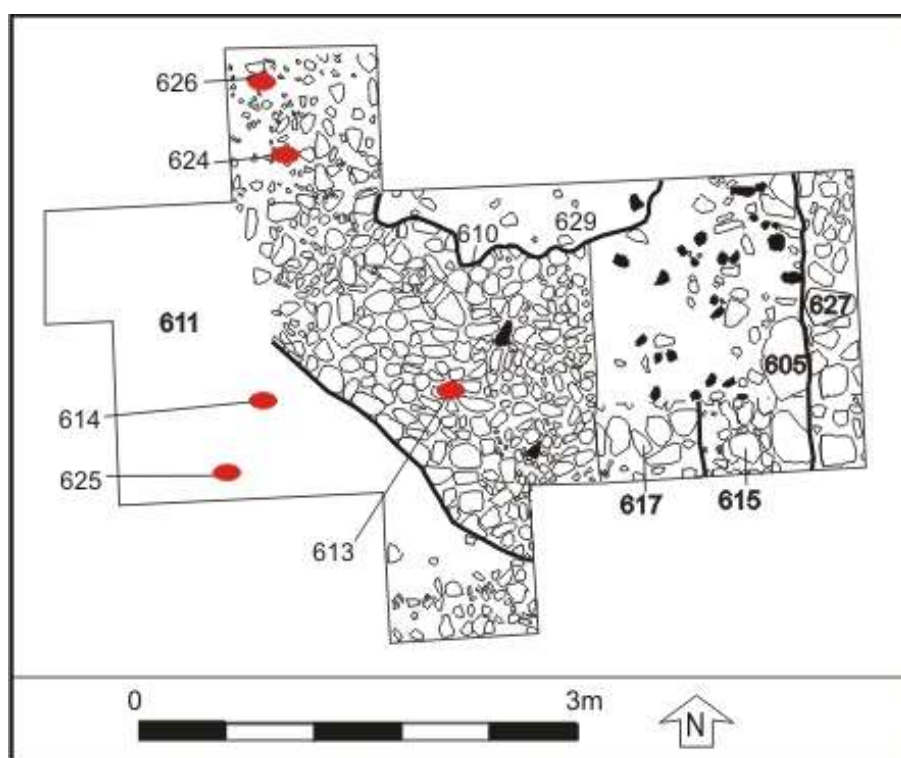
Figure 36 Trench 6 marquee peg holes (in red).

At least five marquee peg holes were identified in this trench (Fig 36); they were 0.02 x 0.04m in size and are evidence of pegs being forced through the cobbled surface 609 and metalled surface 611.

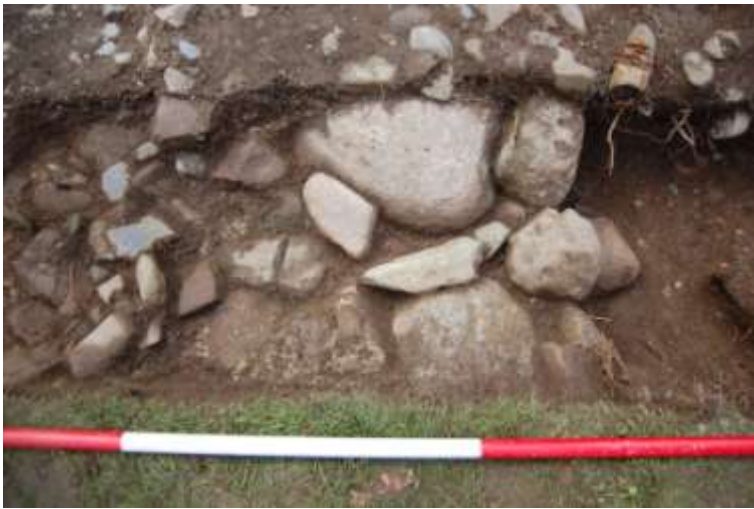
Figure 37 wall foundation 702 (centre) with robber trench 705 (right); facing south

Adjacent to wall foundation 705, the east wall of the chapel had been completely removed down to the base of the foundation trench whereas the garden wall was only robbed down to ground level leaving the foundation intact. There could be several explanations for this including that the garden wall had been removed to ground level prior to the chapel being demolished or that their construction materials were different and the large stones in the garden wall foundation were not required for the rebuilding work on another part of the estate. It is also possible that after the chapel wall foundation was removed, no further building materials were required at that time and everything else was left *in situ*. This would explain other differential robbing including the west wall of the building (605).

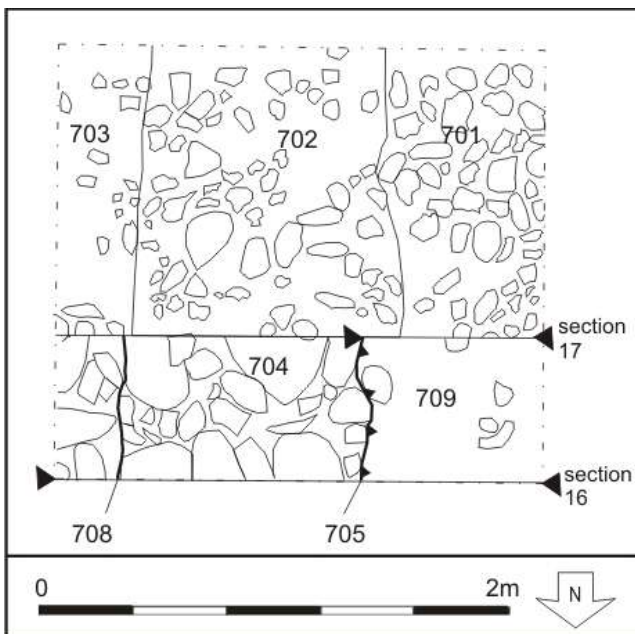
Figure 38 Trench 7 wall foundation 704 (centre) and robber trench 705 (right)

Parallel to robber trench 705/424 was wall foundation 704 (Fig 38) which was up to 1.2m wide and constructed of large stones with small stone hearting. This was probably the foundation of a garden wall which joined on to the SE corner of the castle (see 1002 Trench 10) and surrounded the immediate area forming a private or inner garden. Numerous fragments of red sandstone on top of this foundation suggest that the wall was constructed of sandstone blocks which were removed at demolition.

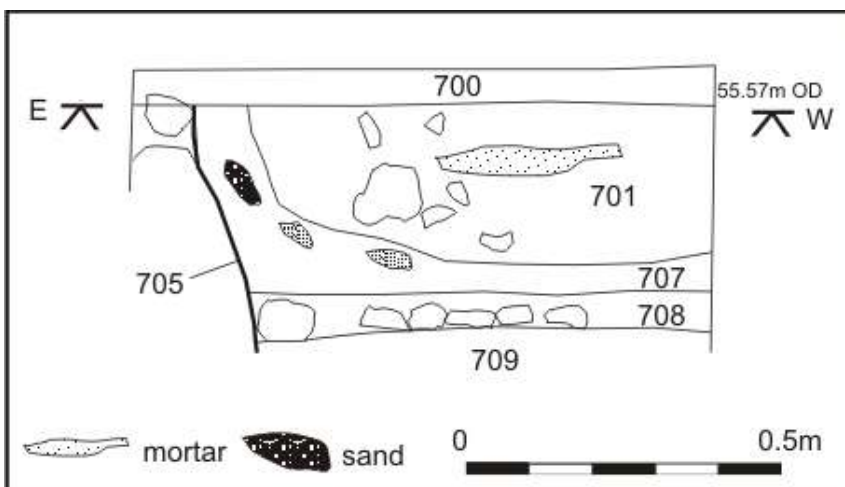
Figure 39 Section 15 showing robber trench 705 and earlier possible cobbled surface 708

The earliest feature in this trench was the remains of a possible metalled or pebble surface at the base of robber trench, 705. This was at 55.22m OD (Section 15; Fig 39); the metalled surface in the base of post-holes in Trench 4 was at 55.35m OD and the surface in Trench 5 (at the SW corner of the castle was at 55.36-55.40m OD.

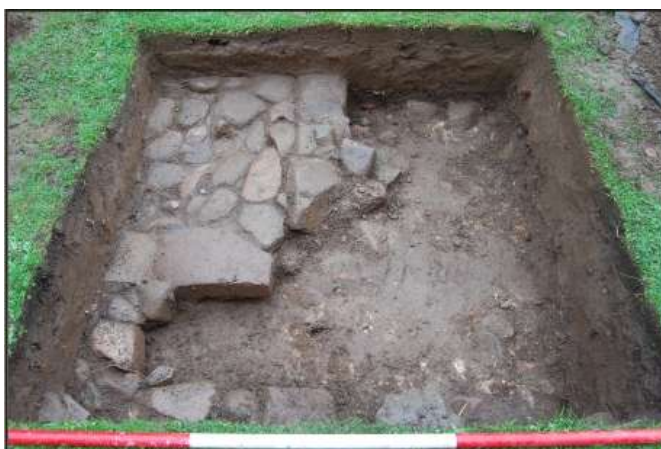
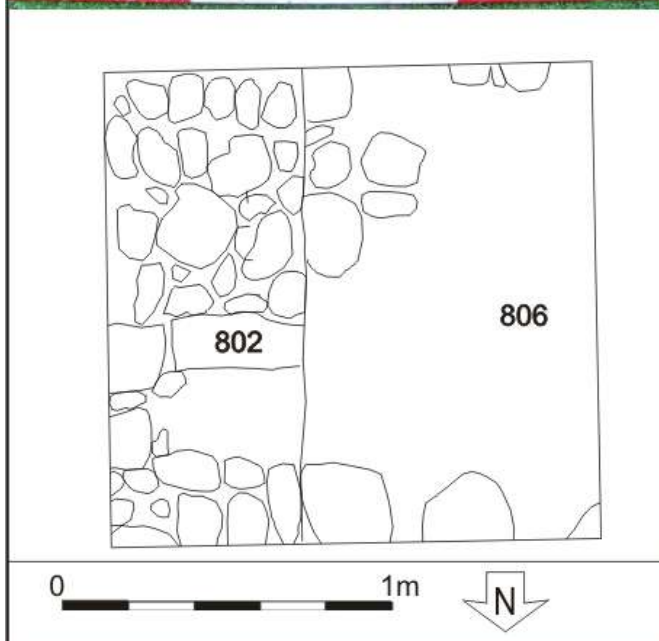
Figure 40 Trench 8 showing robber trench 806 (right) and cobbled surface 802 (left); facing south

Robber trench 806 (Fig 40) was located at the west side of the trench where the wall foundation had been completely robbed of large stones as well as the hearing. Along the east side of the trench cobbled surface 802 was a

continuation of surface 402 (Trench 4) and 627 (Trench 6); the surface included one of the larger stones which formed bands across the cobbles in Trench 4. The surface was at 55.63m OD. The north gable wall of the building was not found in this trench and as a result Trench 11 was opened to chase this building alignment.

A small number of cobbles had been removed from surface 802 and this was investigated to determine whether a post had been inserted. No evidence of a post was found but at 55.49m OD a small stone metalled surface was identified.

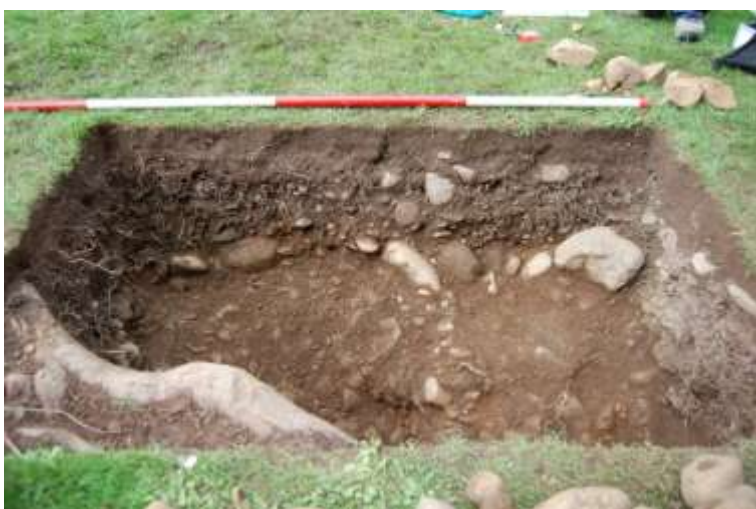
Figure 41 Trench 9 south trench section; facing south

This was excavated 6m south of Trench 7 to check for the continuation of garden wall foundation (704). Up to 0.5m of loose loam and redeposited natural subsoil (901/902; Fig 41) had been dumped in the area of this trench. No evidence of a wall foundation or robber trench was identified. The south end of Trench 4 (2010) had also been disturbed and it is likely that features were removed more fully from this area of the garden and redeposited natural subsoil and loam dumped to make up the height of the area. This may be associated with the realignment of the driveway in the late 18th-early 19th century.
